Precision Home Inspection of Marshall County

ID: 16-144
328 Birdwell Lane
Columbia TN 37475

Summary

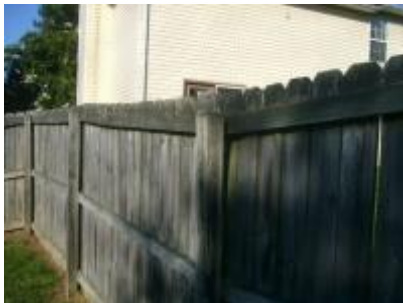
Wood privacy fence is in fair condition. needs some maintenance (see photo)

damaged post

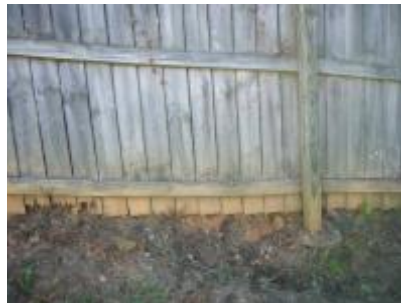
fence boards damaged at bottom

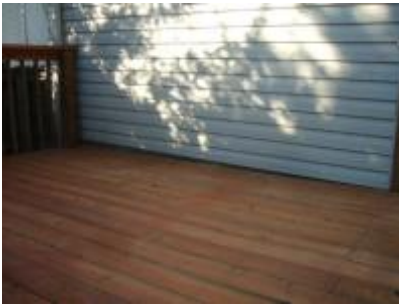
Addition to original deck has settled about 1.5 inches at one corner(See photo)

corner of deck has settled at left. note gap under siding

Recommend corner pier be raised to level deck

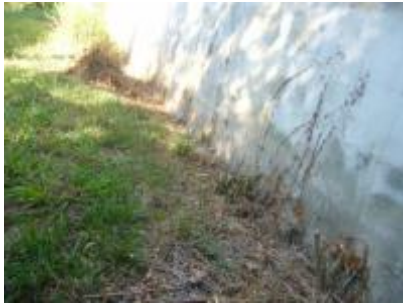
right foundation wall

area along perimeter of house is sunken, allowing lot and gutter drainage to run under foundation. There is a large hole at left side of foundation where water enters. (see photos)

These areas should be filled to direct water away from foundation wall

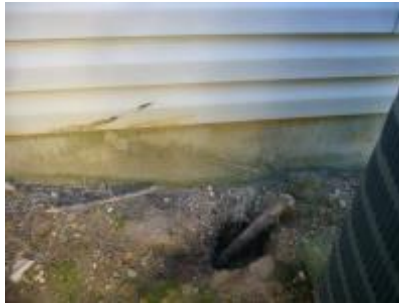
hole in soil seems to drain under house.
Also note siding damage

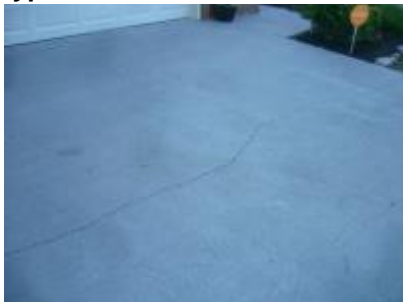
Concrete drive generally in good condition except for random crack (see photo)

crack in upper slab

Recommend this crack be sealed to prevent water intrusion and monitored

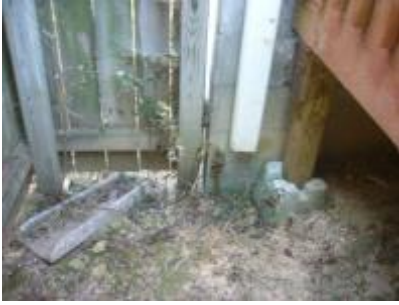
Downspouts should have extensions to direct water away from foundation wall

Downspout needs extension. This water wall has cause deck support to settle

Recommend attaching extensions or adding underground drain pipe to carry gutter water away from house

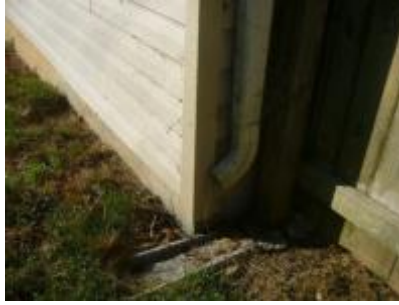
downspout drains along left outside

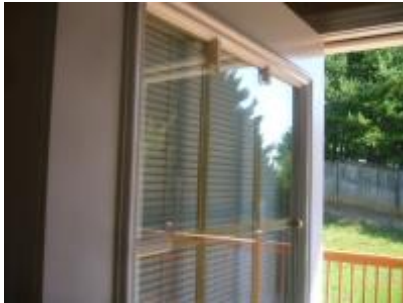
Front door knob latch does not close. Needs adjustment on striker plate Back door to deck....external grill broken (see photo)

rear exit door to deck. Grill broken

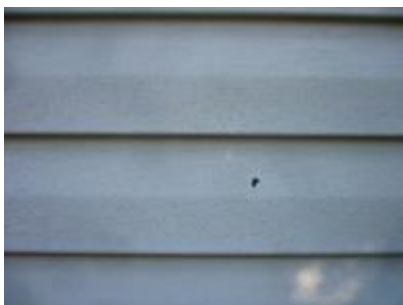
Front of house is brick veneer. Vinyl siding on other three sides. There are small damaged areas on left (bottom) and on right side (see photo)

Small siding hole, right rear corner of house

Recommend these areas be sealed to prevent water intrusion

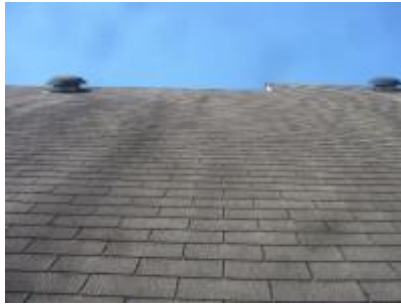
rear roof deck. note two power vent fans

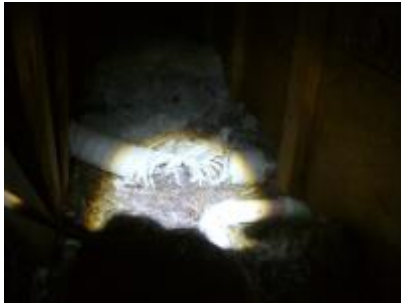
Vent pipe from upstairs bath is damaged from birds in attic (see photo)

damaged vent pipe (behind furnace in attic)

Flexible plastic pipe needs reconnection to external vent

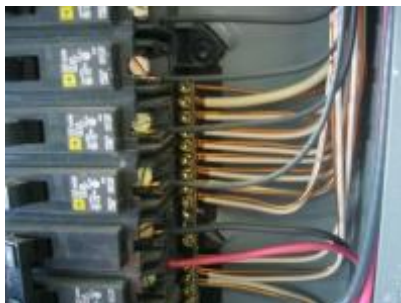
Photo shows more than one size wire per screw lug on neutral buss. This is no longer a recommended practice

note neutral and ground wires (different sizes) under one screw

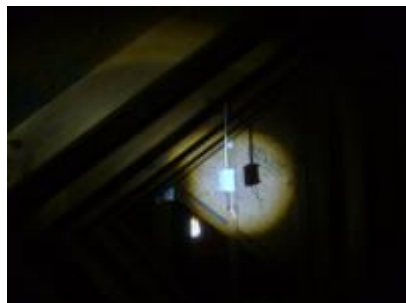
There are gable vents at each end of house. In addition there are two roof power vents, however neither has been connected to power

power vent thermostat and switch
box....not connected

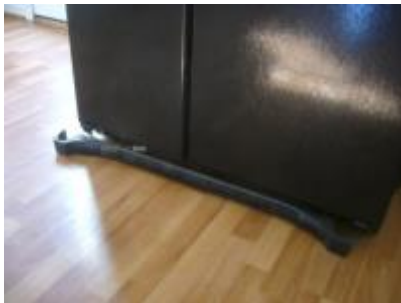
floor grill is not attached to refrigerator

refrigerator floor grill not attached

recommend installing this part

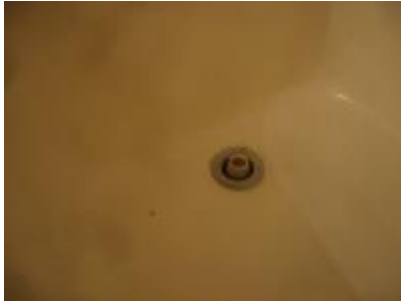
Comments:
upper level hall bath tub stopper cover is missing

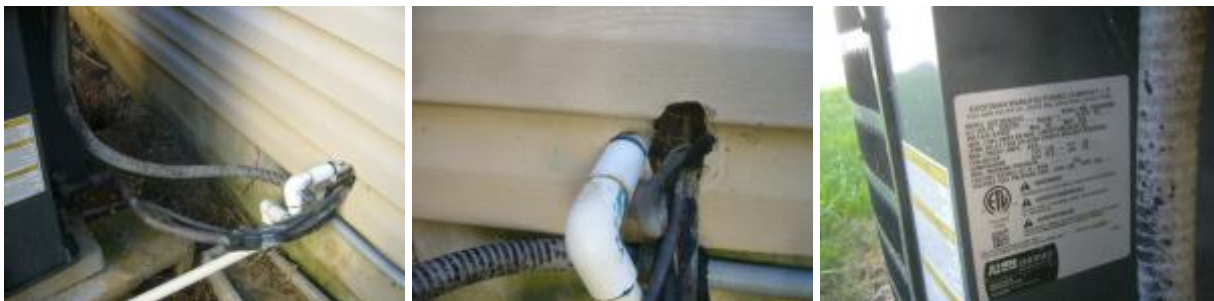
Condenser unit shows manufacture date of 2014... However coolant return line outside needs to be insulated to assure efficient operation (see photo)

insulation needed on return line

lines entering house wall....need sealing

Also lines entering wall of house should be sealed to prevent rodent entry
